Phase I – Initial Site Investigation Report Release Tracking Number 3–34474

RIVER'S EDGE DEVELOPMENT

484 BOSTON POST ROAD WAYLAND, MASSACHUSETTS

AUGUST 14, 2018

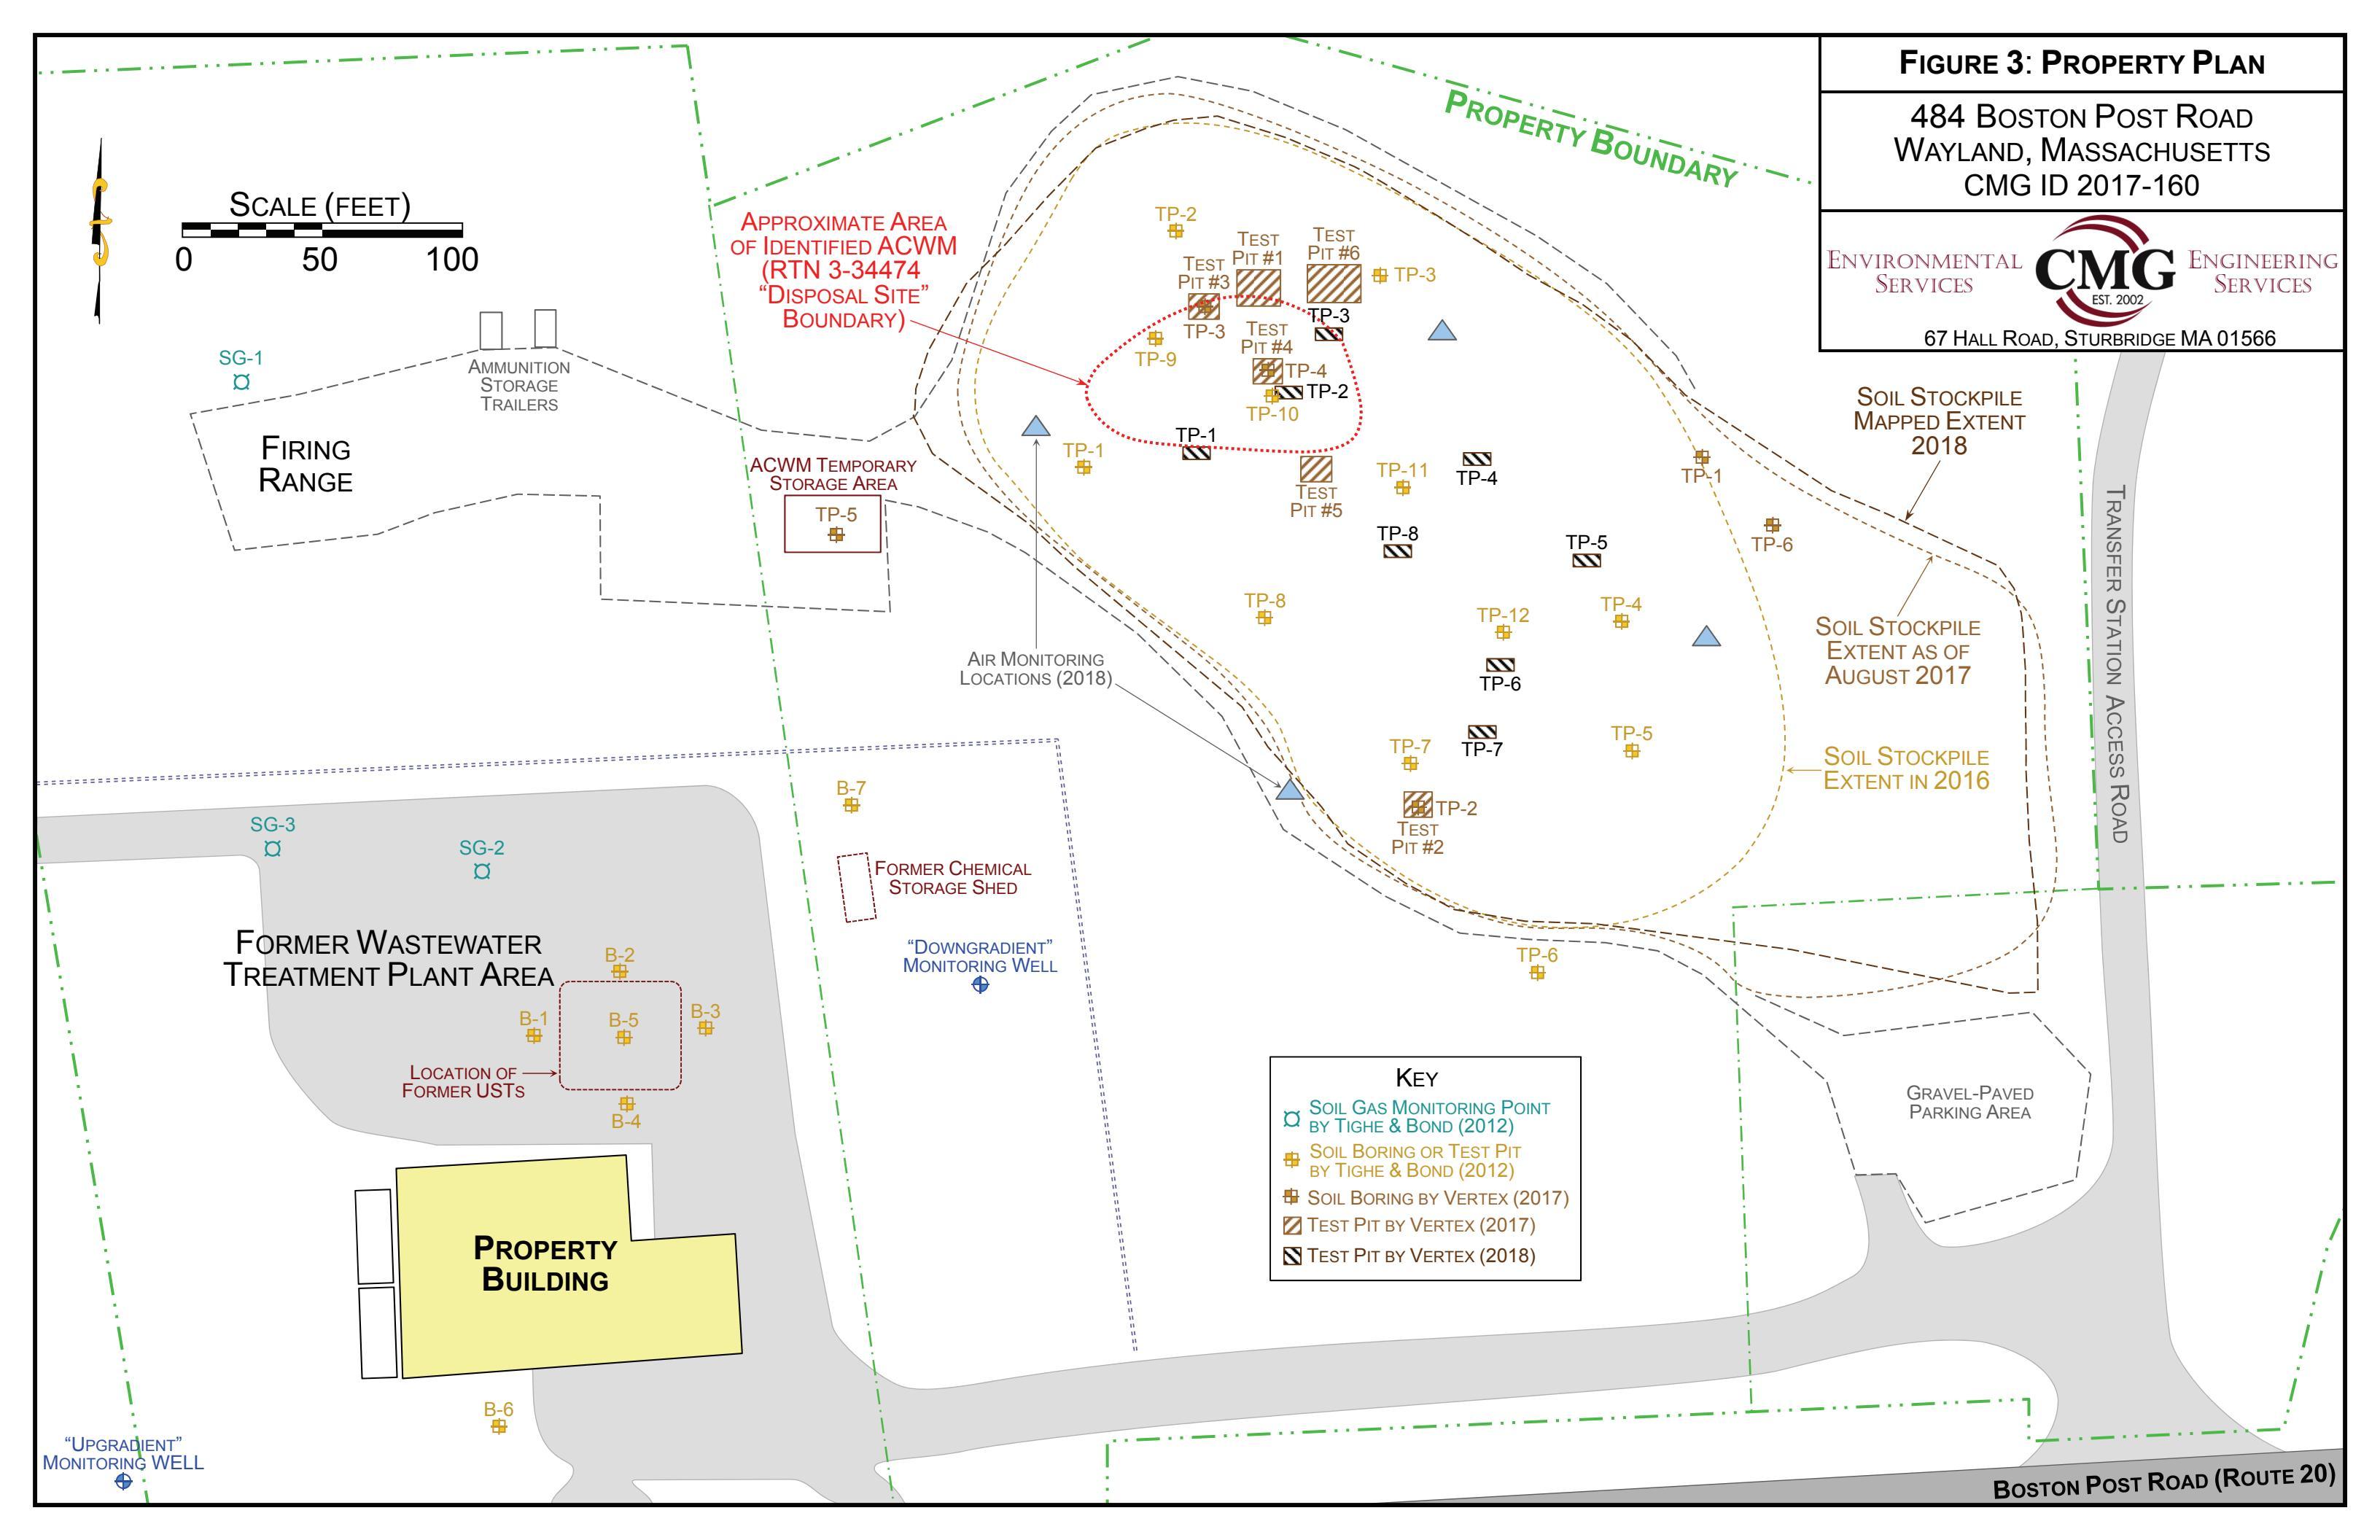
Figure 3 depicts the RTN 3-34474 disposal site boundaries to the extent that subsurface assessment conducted to date has defined them (labeled as "Approximate Area of Identified ACWM"). CMG identifies the 'disposal site' as this area of identified asbestos-containing waste material disposal. Figure 3 also illustrates soil sampling locations at or adjacent to the large Property soil stockpile. These include:

- Vertex soil sampling locations TP-3 & TP-4 within the Site boundary and TP-1, TP-2 & TP-6 at other portions of the soil stockpile;
- Vertex Test Pit #4 location within the Site boundary, Test Pit #1 & Test Pit #3 partially within the Site boundary, and Test Pit #2, Test Pit #5 & Test Pit #6 at other portions of the soil stockpile; and
- Tighe & Bond² test pit locations TP-9 & TP-10 within the Site boundary and test pit locations TP-1, TP-2, TP-3, TP-4, TP-5, TP-7, TP-8, TP-11 & TP-12 at other portions of the soil stockpile.
