IMMEDIATE RESPONSE ACTION INITIAL STATUS REPORT RELEASE TRACKING NUMBER 3-34474

RIVER'S EDGE DEVELOPMENT

484 BOSTON POST ROAD
WAYLAND, MASSACHUSETTS

DECEMBER 8, 2017

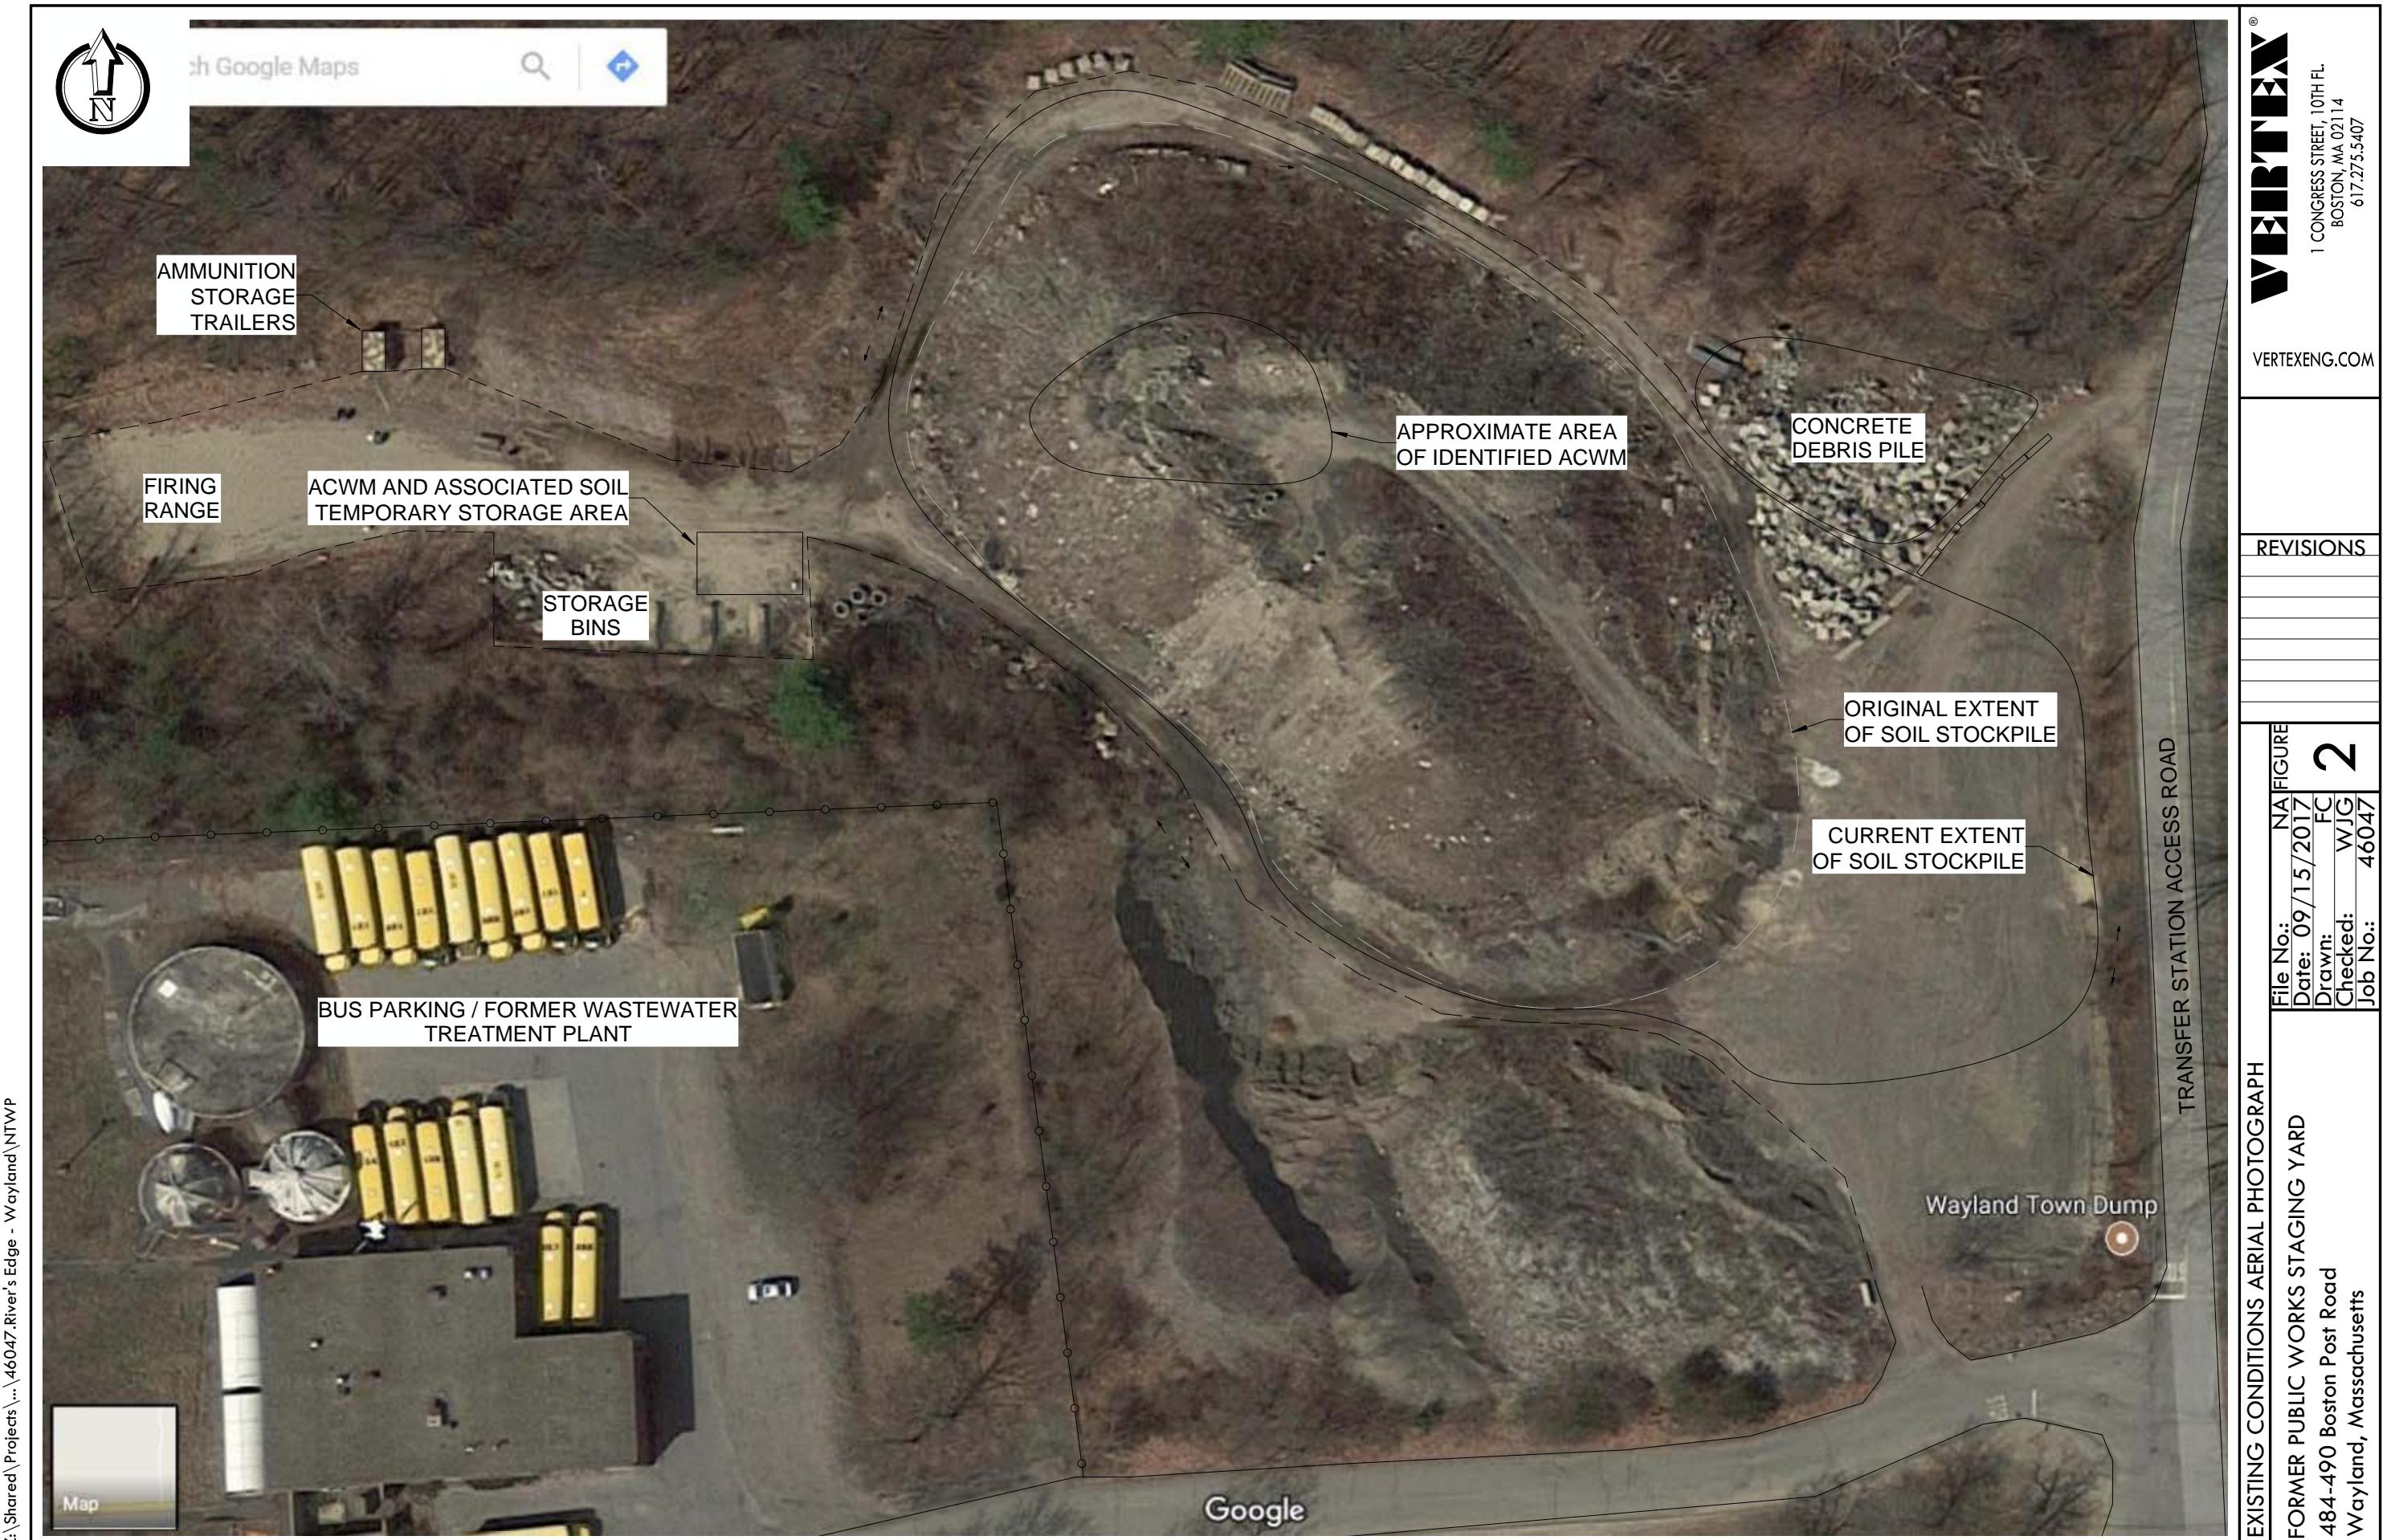
VERTEX* FIGURE 2 – EXISTING CONDITIONS AERIAL PHOTOGRAPH

CMG has appended Figure 2 (Existing Conditions Aerial Photograph) and Figure 3 (Sample Location Plan) prepared by The Vertex Companies, Inc. (Vertex) to this IRA Plan. These figures each depict an “Approximate Area of Identified ACWM” (asbestos-containing waste material) near the apex of the large soil stockpile. CMG considers this area to be the approximate limits of the RTN 3-34474 ‘disposal site.’

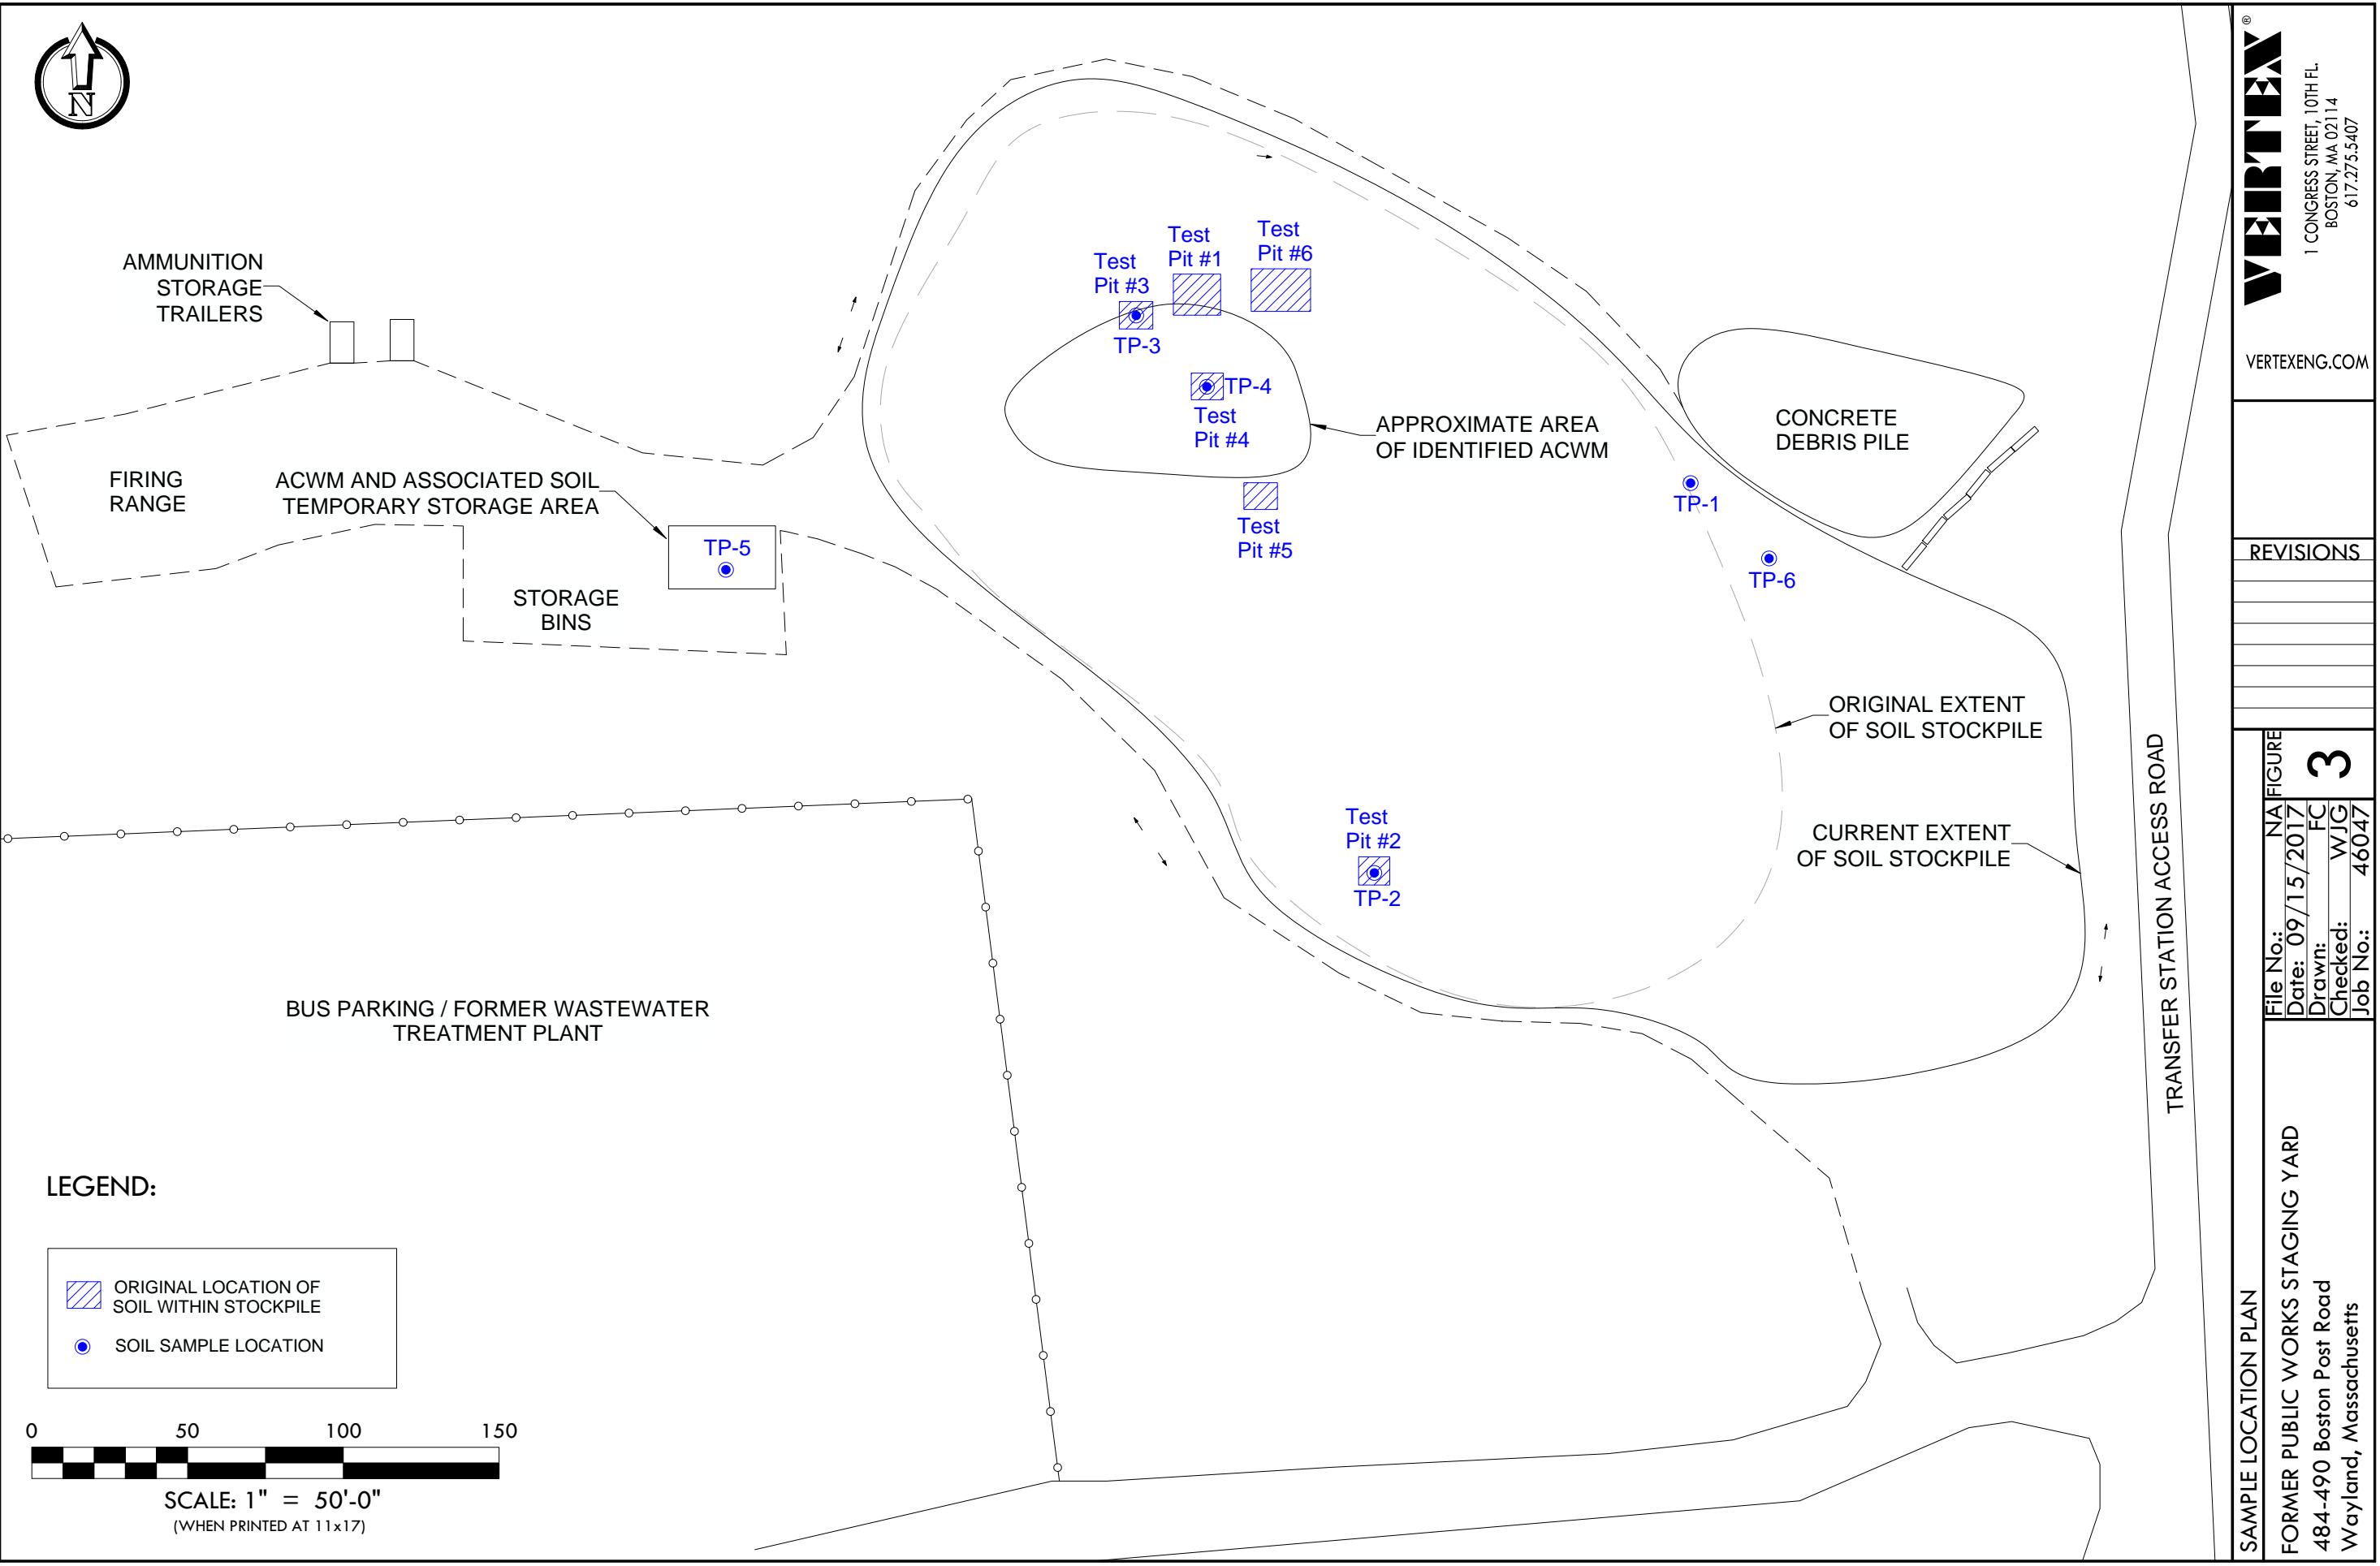
VERTEX* FIGURE 3 – SAMPLE LOCATION PLAN

Vertex is supervising characterization of the large soil stockpile located on Lots 22-6 and 22-7 at the Property. In August 2017 Vertex had this stockpile partially graded into a more manageable configuration to allow sampling for waste classification or potential reuse. On August 8, 2017 Vertex observed suspect ACWM (pieces of 3-4" diameter transite pipe, vinyl floor tile) near the top of the stockpile and halted grading activities. They collected six samples of this material on August 10, 2017 and submitted these for asbestos analysis using polarized light microscopy (PLM) methodology. Five of the six samples contained >1% asbestos.

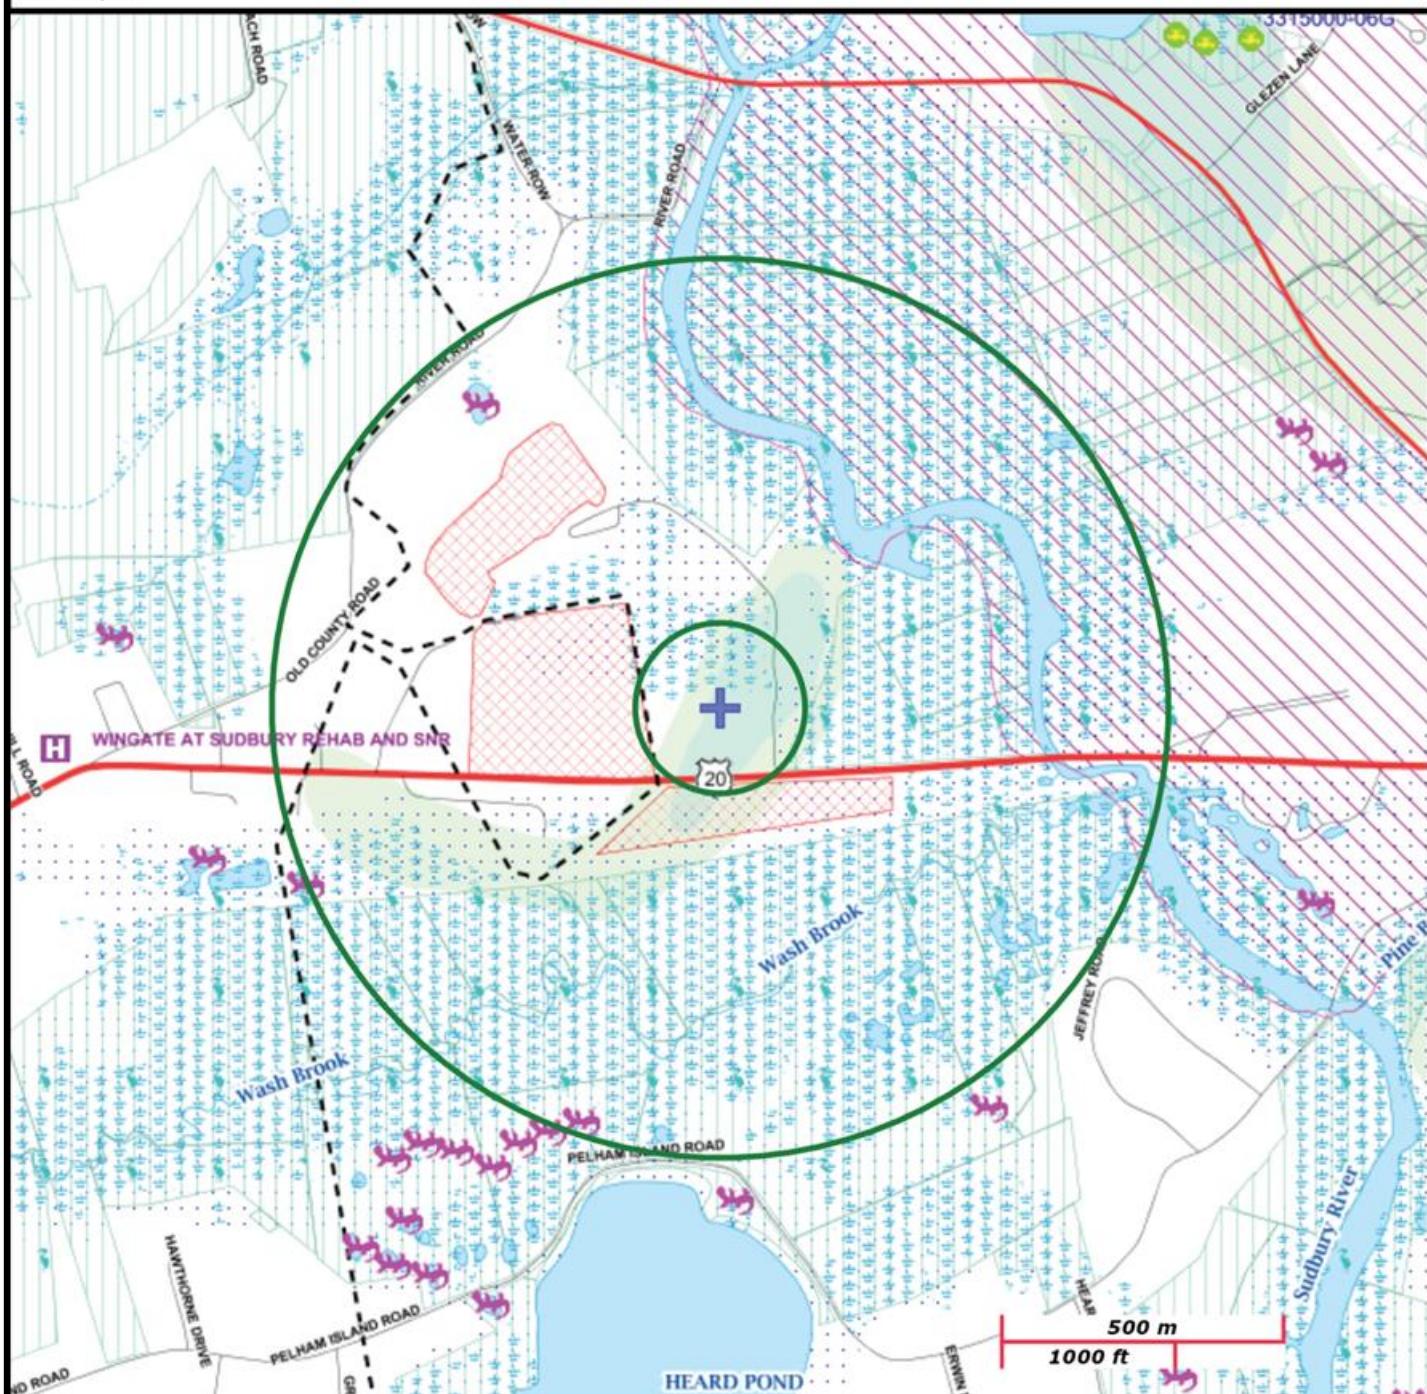
FIGURE 4: PRIORITY RESOURCE MAP
484 BOSTON POST ROAD, WAYLAND MA
CMG ID 2017-160

Phase 1 Site Assessment Map: 500 feet & 0.5 Mile Radii

RIVER'S EDGE DEVELOPMENT
484 BOSTON POST ROAD WAYLAND, MA
3-000034474
NAD83 UTM Meters:
4692950mN, 303850mE (Zone: 19)
October 6, 2017
