Phase I – Initial Site Investigation Report Release Tracking Number 3–34474

RIVER'S EDGE DEVELOPMENT

484 BOSTON POST ROAD WAYLAND, MASSACHUSETTS

AUGUST 14, 2018

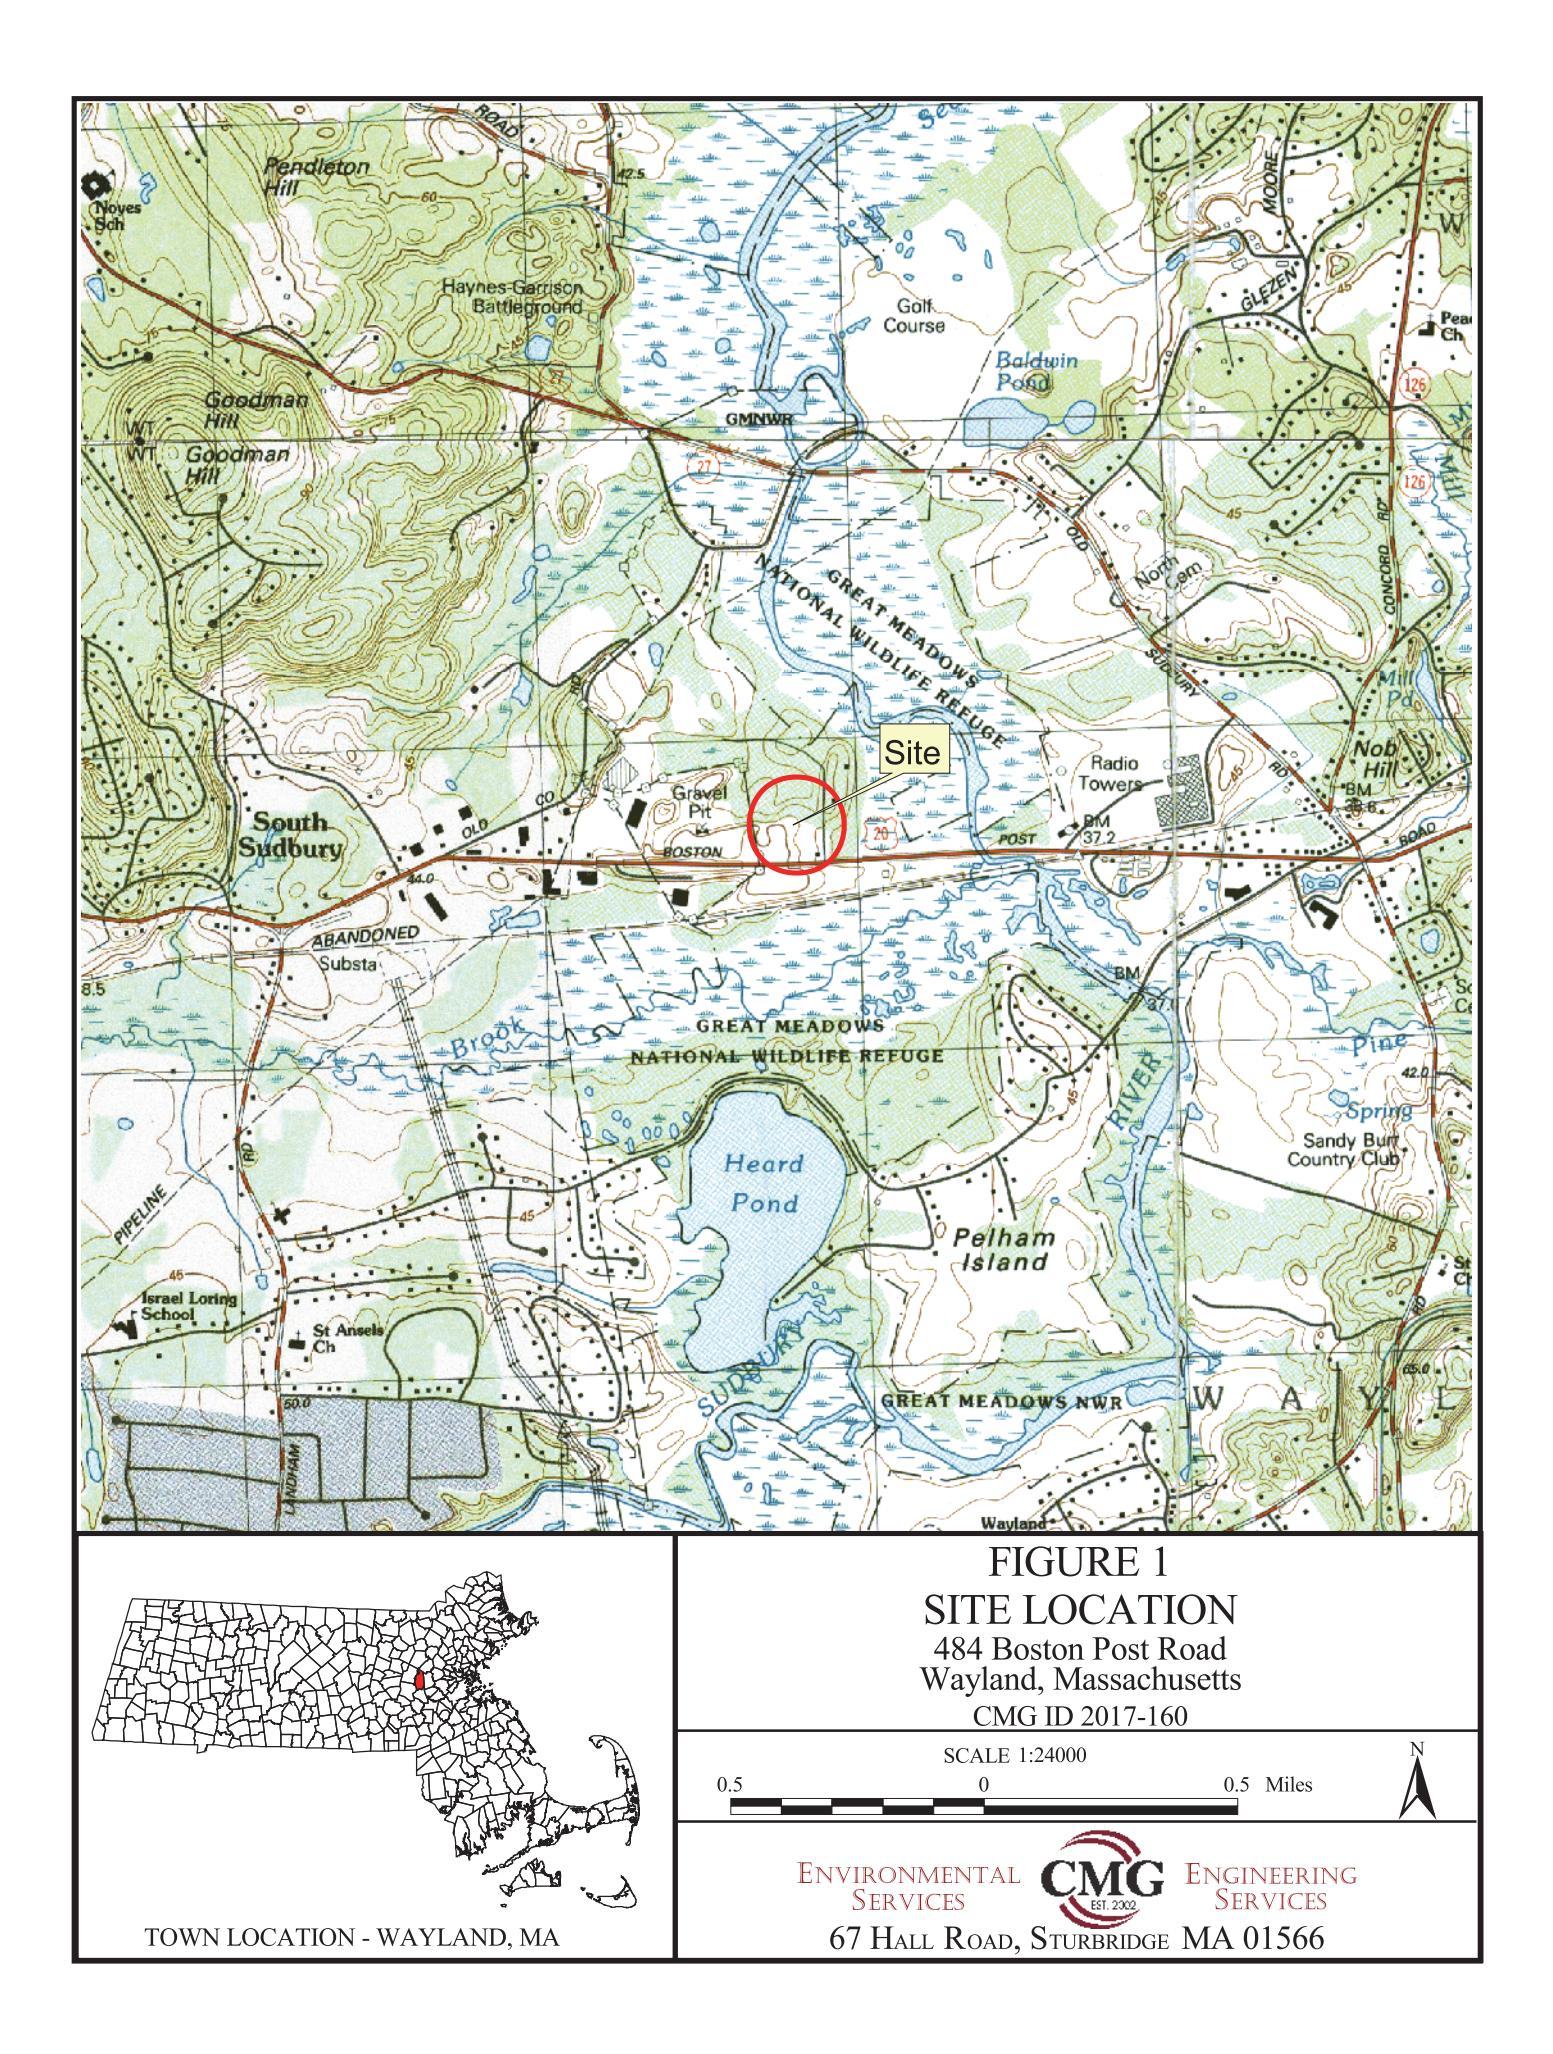
Figure 1 (Site Location) shows the Site (disposal site) locus in relation to streets and other topographic features on the United States Geological Survey (USGS) Framingham, Massachusetts quadrangle.

The Property is at an elevation between 39-48 meters (128-157') above the National Geodetic Vertical Datum of 1929 (NGVD) according to the USGS Framingham, Massachusetts topographic quadrangle (see Figure 1). The ground surface slopes slightly down to the east and north, towards the nearby Sudbury River. T&B estimated the height of the large soil stockpile to be approximately 40' above native grade in 2012 (which grade is approximately 42 meters, or 138' NGVD). CMG observed the soil stockpile to be approximately 30' above grade in 2017 after Vertex had initiated regrading activities. Therefore the elevation of the Site portion of the Property is approximately 165' (50 m) NGVD. CMG did not observe any bedrock outcrops at or in the immediate vicinity of the Site.

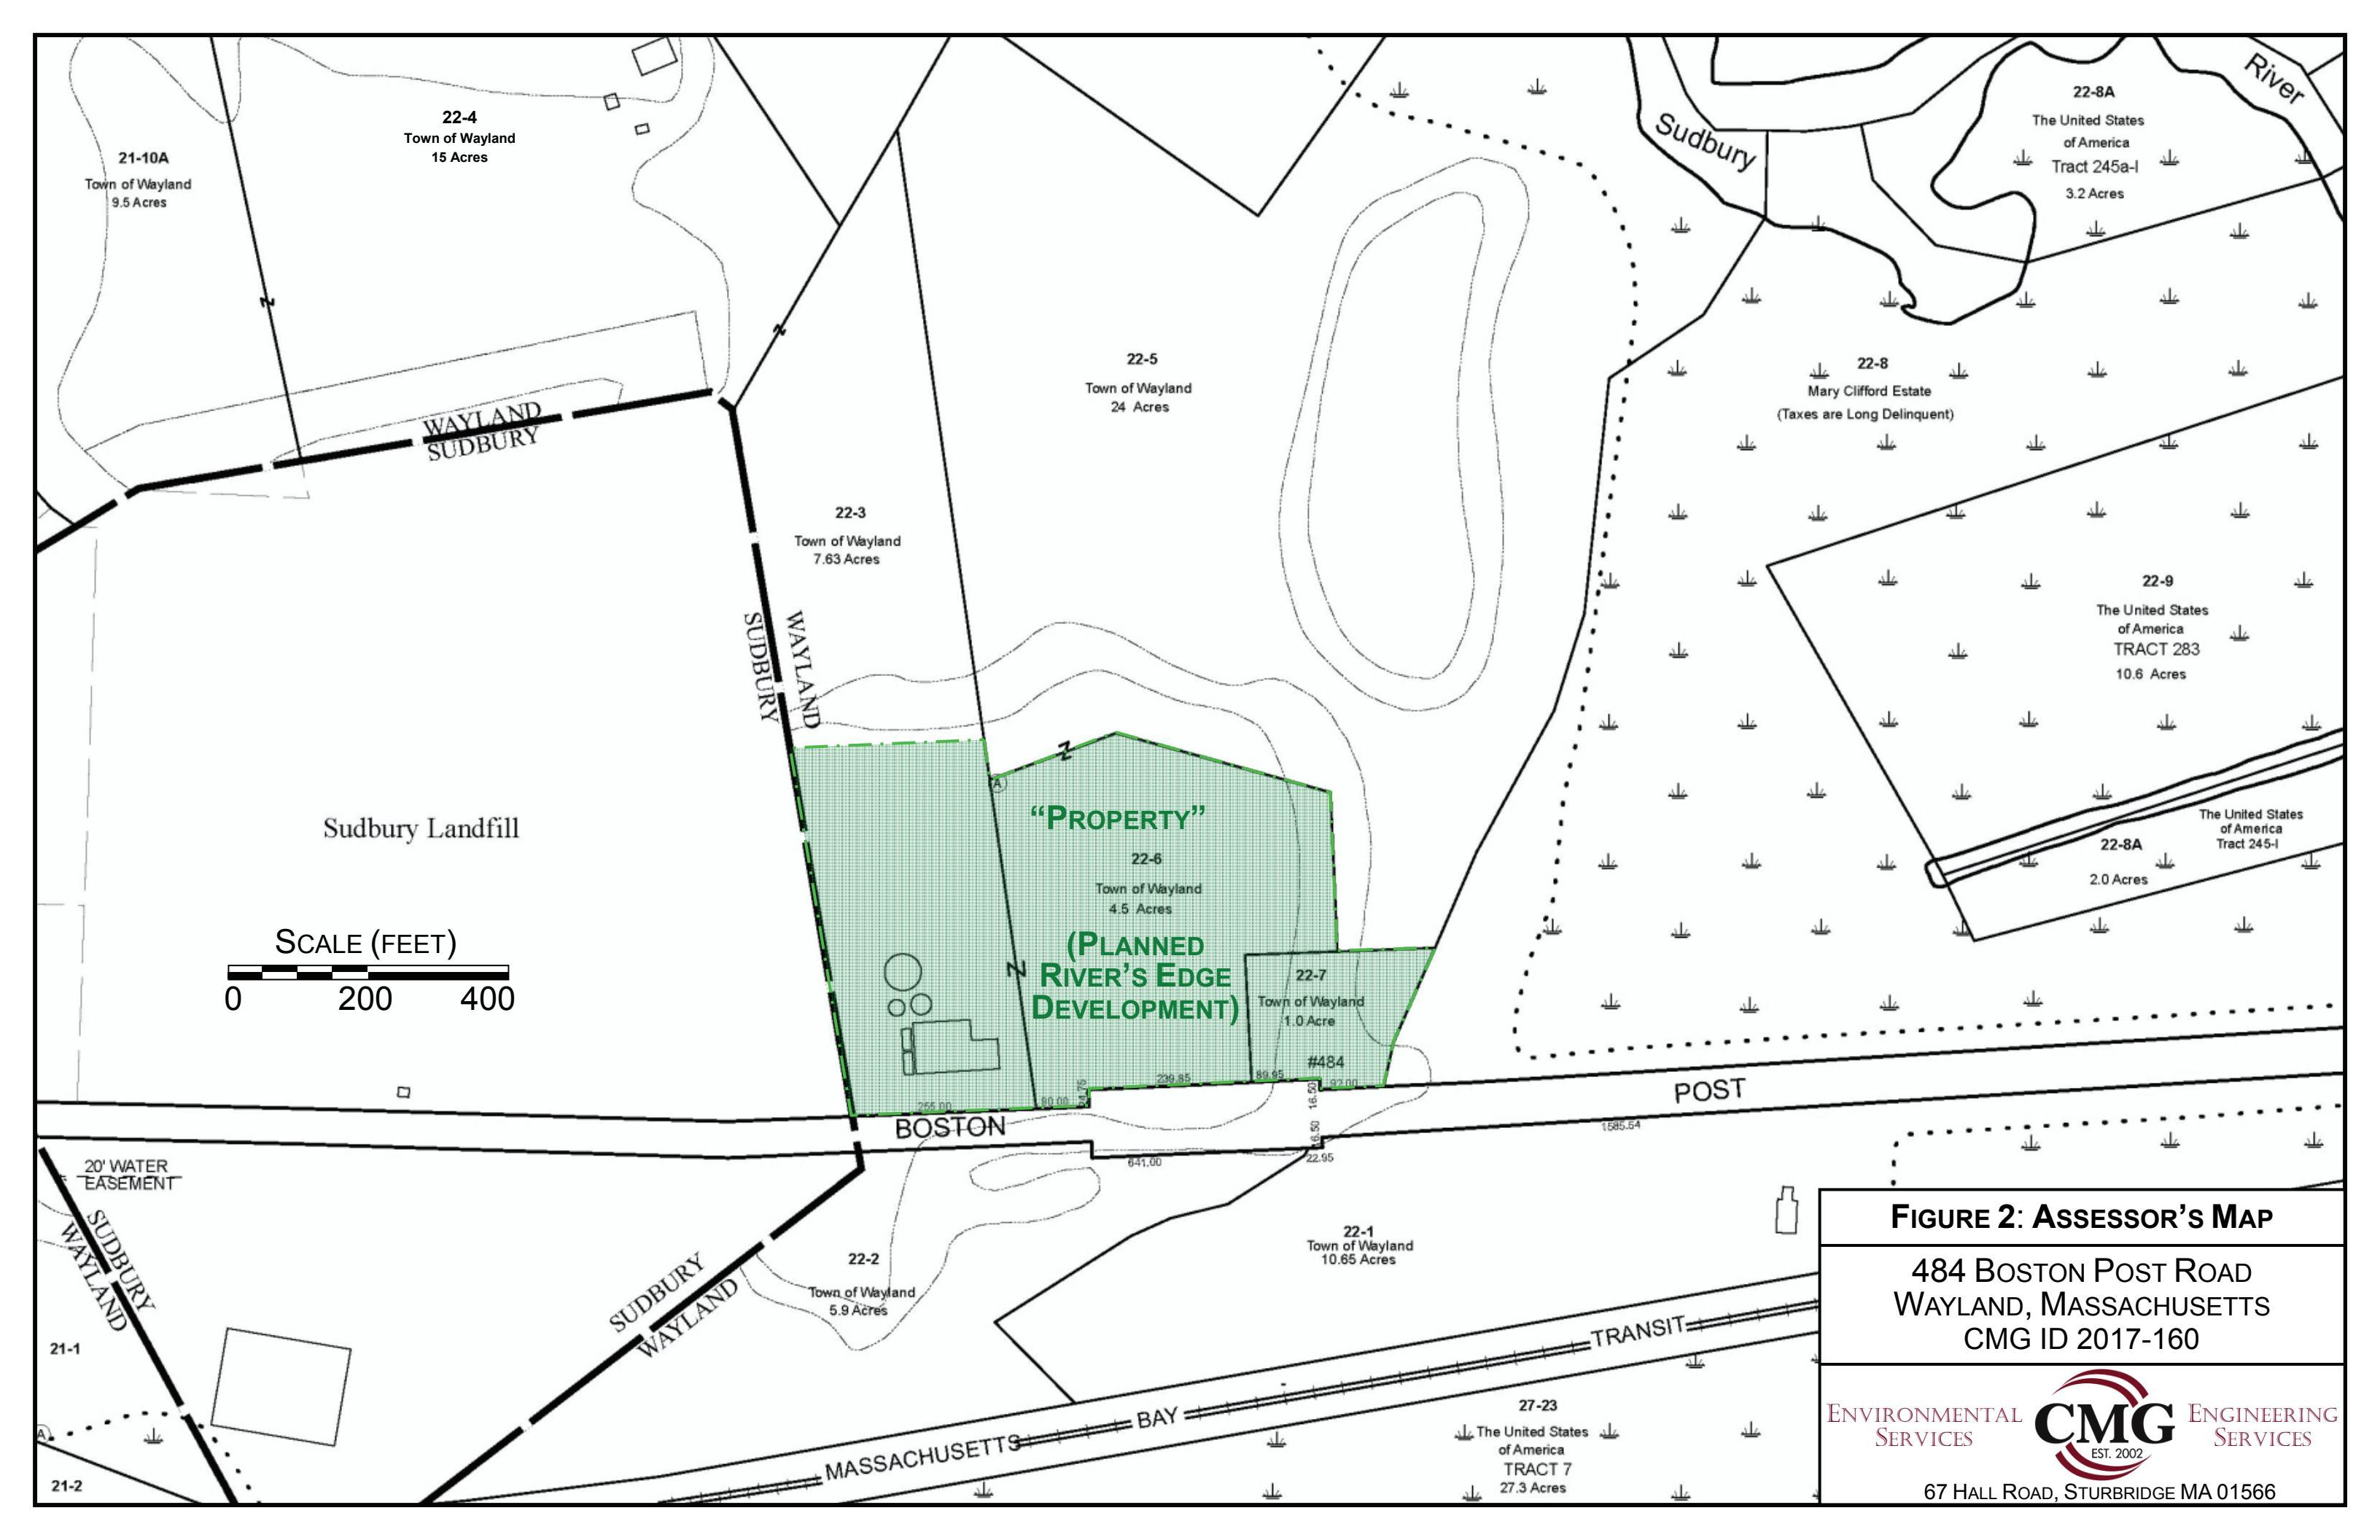
The entire property addressed as 484 Boston Post Road consists of parcels of land identified on Wayland Assessor's Map 22 as Lots 22-3 (7.63 acres), 22-4 (15 acres), 22-5 (24 acres), 22-6 (4.5 acres), and 22-7 (1.0 acre). The Town of Wayland has designated Lot 22-6, Lot 22-7, and the southerly half of Lot 22-3 as the planned "River's Edge" development (which comprises about 7 acres of land). CMG will herein refer to these 7 acres as "the Property" (see Figure 2).

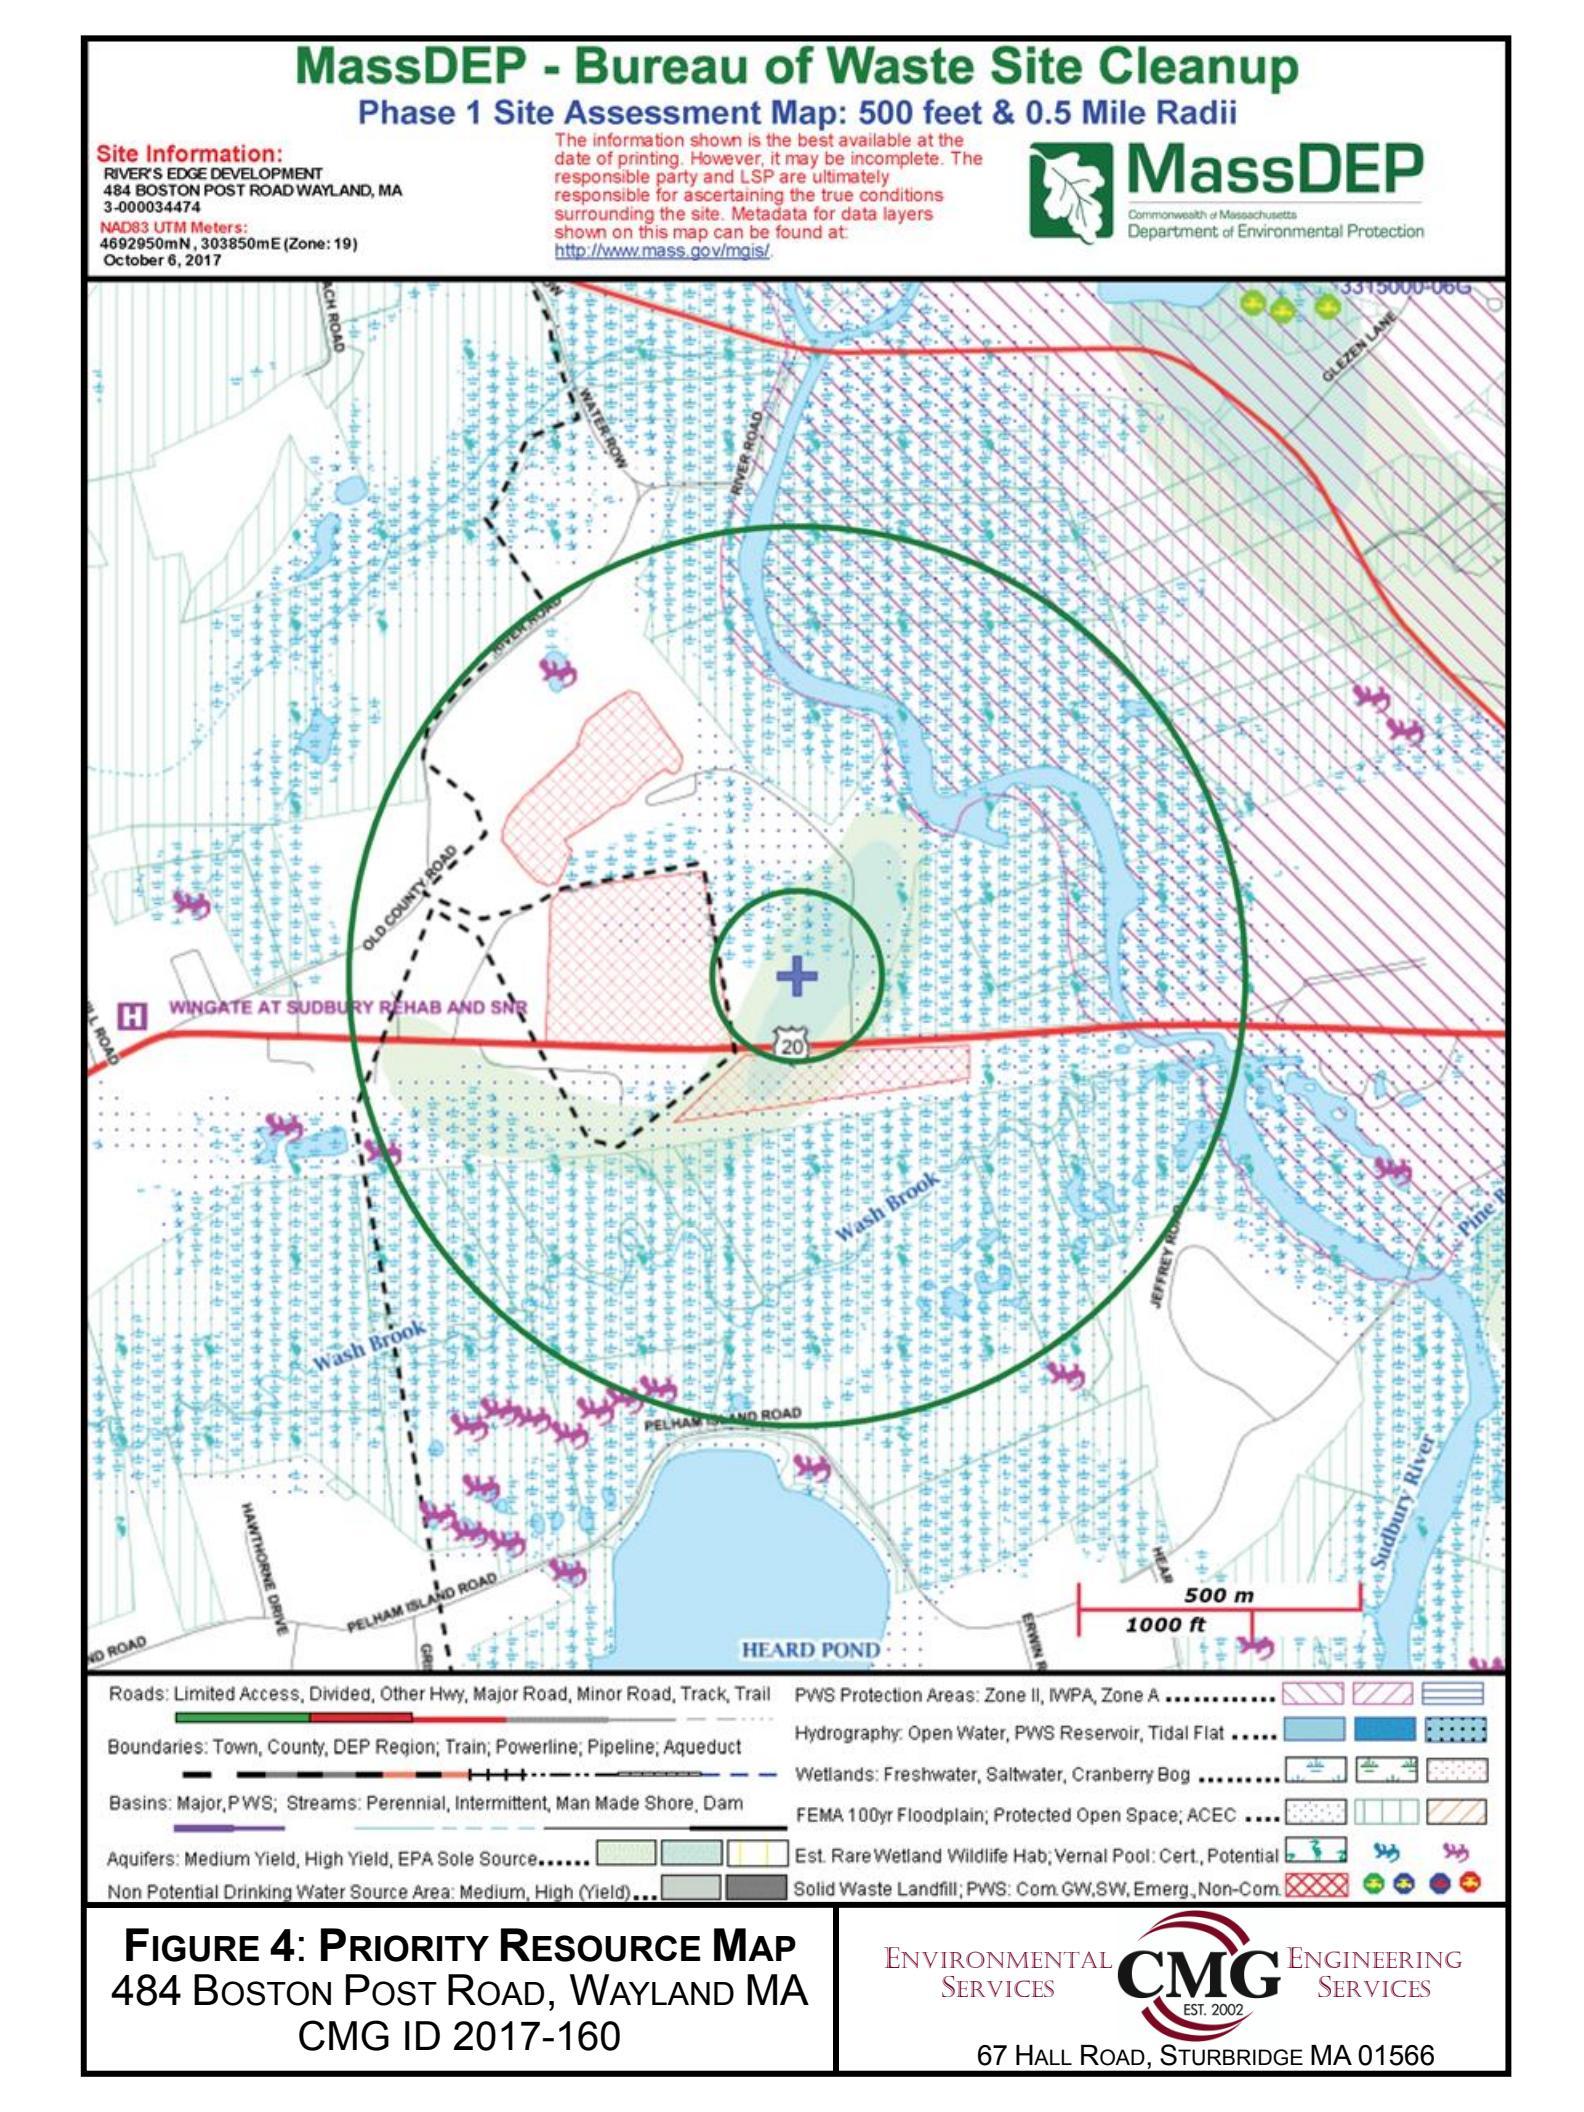
Figure 4 (Priority Resource Map) illustrates 500' and ½-mile radii surrounding the Site. There are no Zone II areas or Interim Wellhead Protection Areas within 500' of the Site. However, the Site is within a mapped high-yield Potentially Productive Aquifer. The Massachusetts Division of Water Pollution Control does not indicate any Zone A areas within 500' of the Site. There are no private wells within 500' of the Site According to Wayland Board of Health information.

Figure 4 does not depict any Sole Source Aquifers; local, state and/or federal protected open space; fish habitats; or habitats of Species of Special Concern or Threatened or Endangered Species within 500' of the Site. However, there is an area of estimated rare wetland wildlife habitat approximately 500' to the east-southeast.

Wooded areas of the Property are contiguous with other woodlands and wetlands along the Sudbury River that extend northerly to the Great Meadows National Wildlife Refuge. The DEP Priority Resource Map for the Site vicinity (see Figure 4) indicates an estimated area of rare wetland wildlife habitat within 500' southeast of the Site that continues along the Sudbury River.
